Test Report

No.: CANHL25011528401

Sample Description: Silicone Leather

US FDA 21 CFR 175.300 - Total extractives

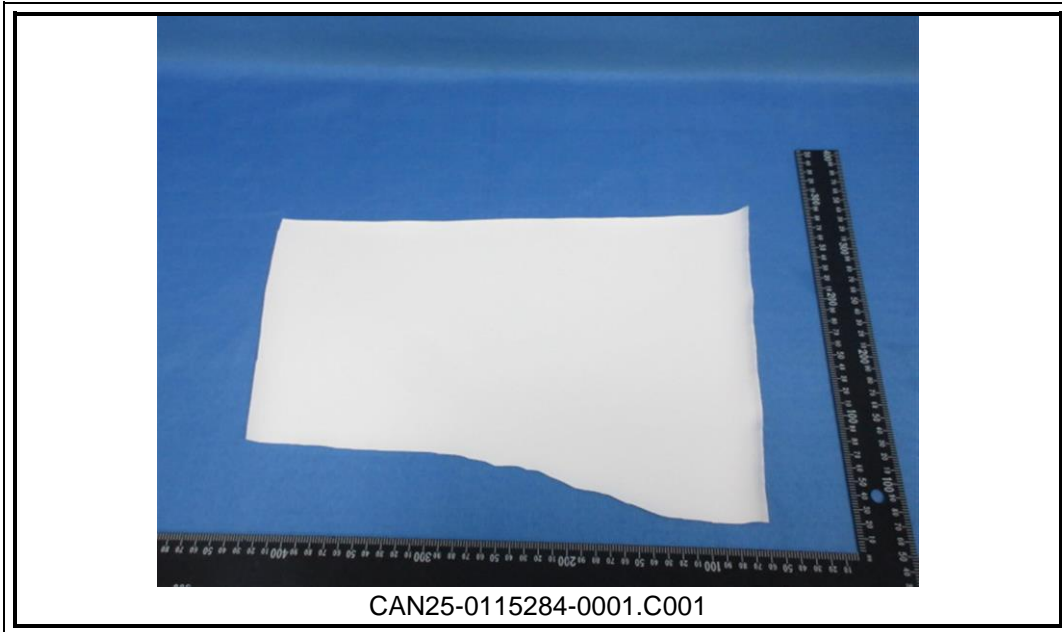
Sample Photo:

SN ID	Sample No.	SGS Sample ID	Description	Material (claimed by the client)
SN1	A1	CAN25-0115284-0001.C001	White sheet	Silicone leather
